Lettre-Service

No. 1673-67-04

Main rotor rotating clockwise

SUBJECT: Reminder concerning the YAW axis control for all helicopters in some flight conditions

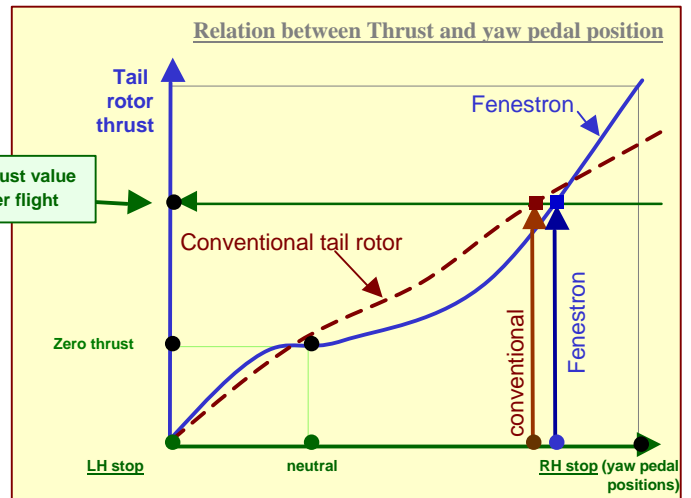
Yaw pedal positions around the hover flight

The « *yaw pedal position / tail rotor thrust* » law curve shape is not the same for a « *conventional* » rotor and a « *Fenestron* ».

For the same thrust value needed for hover flight, the Fenestron requires a little more action to be applied to the RH yaw pedal.

But in hover flight, the same variation of yaw pedal position will result in **more significant effect** with the Fenestron than with the conventional rotor.

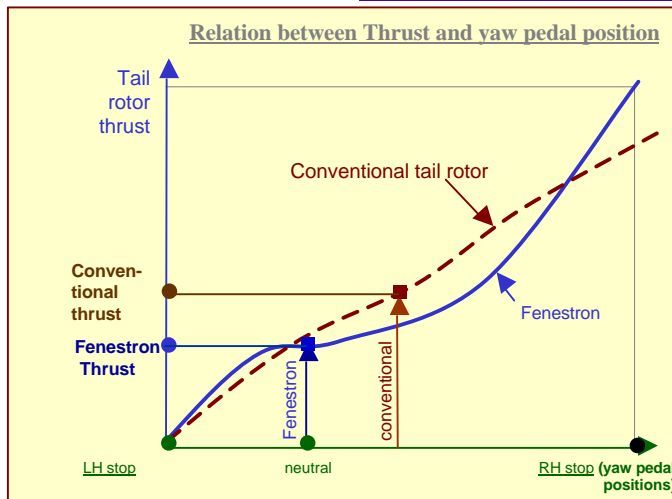
Yaw pedal position in cruise flight

In cruise flight, the **conventional rotor** delivers a thrust which comes in addition to its vertical stabilizer profile effect, so as to maintain zero sideslip.

As regards the **Fenestron**, since the fairing effect is higher due to its large surface, the thrust to be applied by the tail rotor is lower.

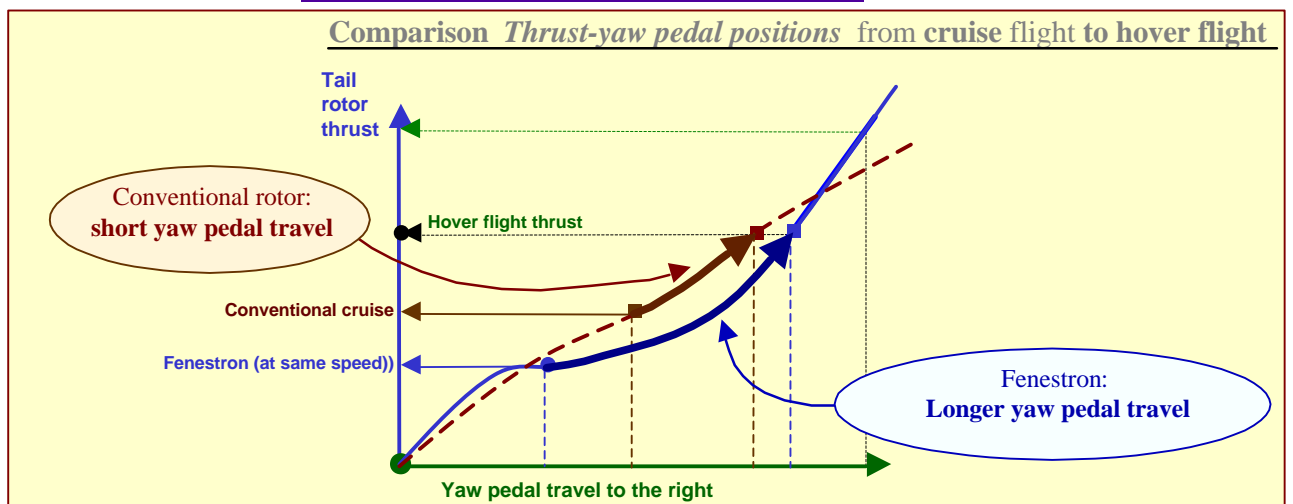
Transition from cruise flight to hover flight

With a Fenestron, when changing from **cruise flight to hover flight**, be prepared for a **significant movement of the foot to the right**.

Insufficient application of pedal would result in a leftward rotation of the aircraft during the transition to hover.
